LEAD Center/ASUC Auxiliary

102 Hearst

Consultation Date: October 19th, 2012

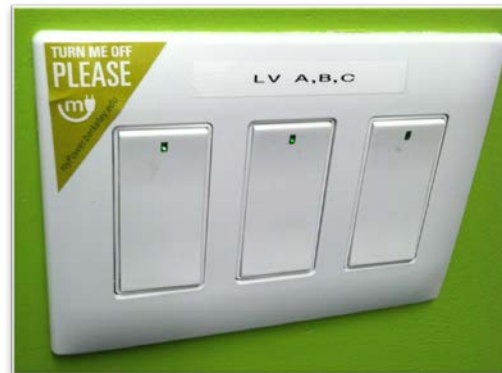
- Building has access to natural light.
- However, film over windows reduces brightness, forcing extra lighting to be incorporated.
- Both task lighting and overhead lighting used concurrently.
- Overhead lights are turned off automatically at 7pm every day.
- Occupancy sensors are installed.
- Most sensors do not operate correctly.
- Areas near Northern windows are over lit due to task and/or overhead lighting used concurrently with natural light.
 - 631 to 345 LUX

- Create an office check list for closing to turn off lights, printers, monitors, and other electronic equipment.
- In the student debate room, unplug fans when not in use and unplug refrigerator when no items are in it.
- Consider purchasing ENERGY STAR appliances.
- Use task lamps instead of overhead lights when possible.
- Remove items on top of refrigerators, this can reduce energy usage and the temperature of the room.
- Clean coils and defrost the refrigerator annually.

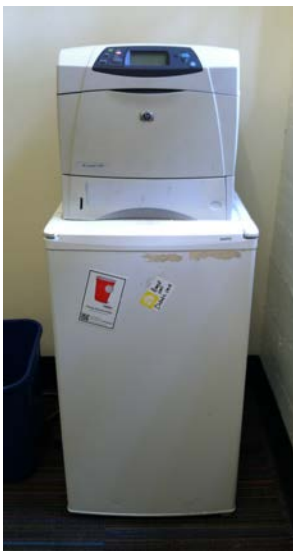
- Occupants do not unplug appliances or turn off power strips when appliances are not in use.
- Refrigerator's fans and coils are not cleaned regularly.
- Refrigerator is not defrosted regularly.
- Items on top of refrigerator prevent heat from escaping easily.
