SAVING ENERGY On Campus

South Hall

Consultation Date: 11/16/2012

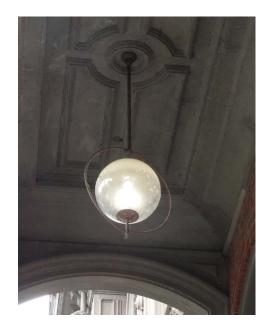
The majority of the building has access to large windows and natural lighting, but overhead lighting is still used. Occupancy sensor lighting has been installed in several areas. It appears that very few task lamps are in place in the offices and student lab section. Also, during our daytime survey, we took note that the oudoor lighting was left on, along with a light in a naturally well-lit atrium (see photo on back). We have placed some stickers on lightswitches in the building to remind people to turn them off.

- ☐ Utilize natural light as much as possible.
- ☐ Consider using half the overhead lighting if possible.
- ☐ Consider purchasing task lamps as a substitute to overhead lighting; ensure that task lamps are equipped with LED or compact fluorescent bulbs.
- ☐ Assign an occupant on each floor to turn off lights at the end of the day.
- ☐ Turn off lights manually when leaving a room.

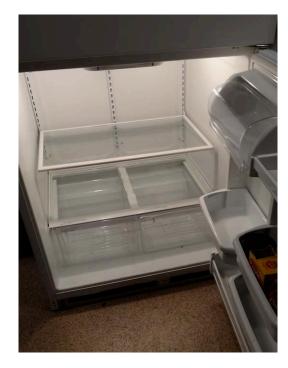
There were a significant amount of kitchenette appliances in the student lab basement. The majority of appliances were plugged in even though not in use. The microwave was placed on a power strip and was utilized properly. There are two full-size refrigerators , one of of which was almost empty (see photo on right). Also, there were excessive items on top of the fridges which makes them have to work harder to keep internal temperatures cold. The freezers appear to be defrosted properly. Other electronics (i.e. radios and chargers) were left plugged in.

- ☐ Consolidate refrigerators if possible.
- ☐ Clear items from top of fridge (prevents higher energy use to generate cold temperatures).

- ☐ Unplug appliances after use, or put them on a power strip and turn off the entire strip when done.
- ☐ Continue defrosting freezer regularly.
- ☐ Place reminder stickers conspicuously to remind occupants to unplug appliances when not in use.
